ANALYZING THE SPILLWAY FAILURE OF THE MONTEDOGLIO DAM IN CENTRAL ITALY

Montedoglio Dam

The destructive event

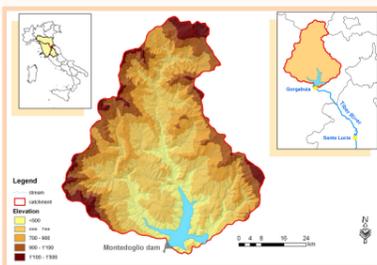
Figure 1: Catchment subtended by the Montedoglio dam and position of the two gauged river sites, Gorgabuia and S. Lucia.

The Montedoglio dam, located approximately 30 km far away from the springs of the Tiber River at Mount Fumaiolo, was built in the 1980s for irrigation and drinking water purposes. The characteristics are reported in Table 1. One hydrometric station, situated in the reservoir, has been operating since 1990. Two further gauged river sites are located downstream of the dam wherein a reliable rating curve is available; i.e. Gorgabuia, immediately downstream the dam, and S. Lucia, 31 km downstream the dam (Figure 1).

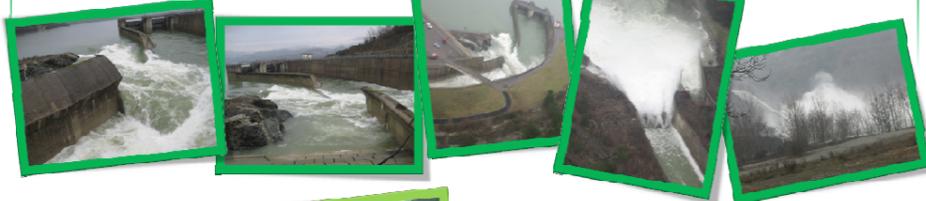
A dambreak occurred during the test.

Three concrete blocks of the spillway collapsed. At 9:43 p.m. the "alarm" was announced and dispatched by the managing authority. Soon after the Civil Protection Agency acted with the planned activities aimed to predict and manage the event as well as to prevent casualties.

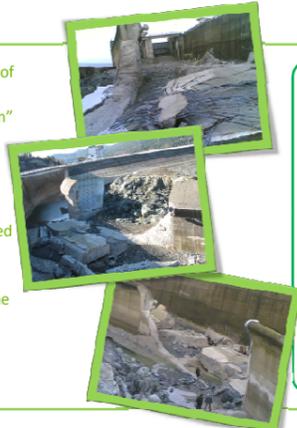
The huge water volumes through the spillway breach produced typical hydrographs characterized by steep rising limb and long recession limb as can be seen in Figure 2 showing the discharge hydrographs recorded at Gorgabuia and S.Lucia gauged sites.

Figure 2: Discharge hydrographs observed at Gorgabuia and S. Lucia hydrometric station caused by the collapse of dam.

The propagation of the flow along the Tiber River caused flooding and the value of the observed peak discharges can be associated with a return period ranging from 500 years immediately downstream of the dam to 30 years at S.Lucia, approximately.

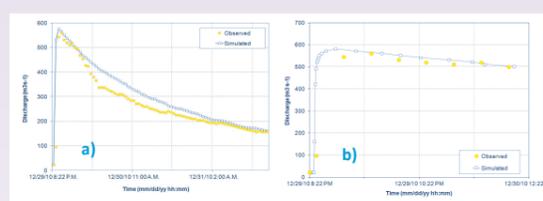
The optimum time interval of the breach failure was found equal to 0.02 hours and Figure 4a shows the computed discharge hydrograph due to failure against the one observed at Gorgabuia site. As it can be seen, the recorded discharge is well reproduced with a Nash-Sutcliffe coefficient, NS, equal to 73% and an error on peak discharge not exceeding 3%. The NS value raised up to 98% if the first part of the recession limb is considered (Figure 4b).

Figure 4: a) Comparison of the observed and simulated discharge hydrographs at Gorgabuia gauged section; b) of the rising limb and the first part of the recession limb.

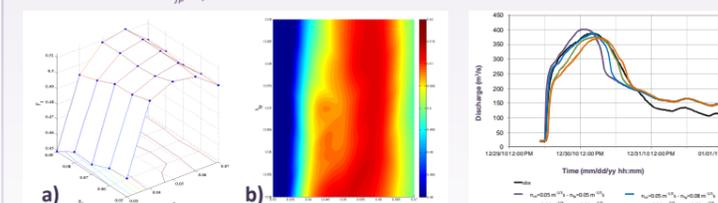
Figure 5a shows the mesh plot of the index F for each specific combination of n_{ch} and n_{fp} . Figure 5b shows the corresponding contour plots that enable to better visualize the influence of the channel and the floodplain roughness on F values. As can be seen, F increases with n_{ch} up to a value of 0.06 m^{-1/3}s and, afterward, decreases. Moreover, F is found slightly affected by n_{fp} value; however, a maximum of F can be observed for n_{fp} equal to 0.08 m^{-1/3}s.

Figure 5: Computed flooded areas analysis: variability of discharge of measure of fit F as a function of Manning's roughness coefficients for the channel n_{ch} and the floodplain n_{fp} .
